**Flood Control Project Maintenance  
Levee Inspections**

**Fall 2018 Levee Maintenance Deficiency Summary Report**

**Sacramento River Basin**

**Sacramento Maintenance Yard Willow Slough Bypass**

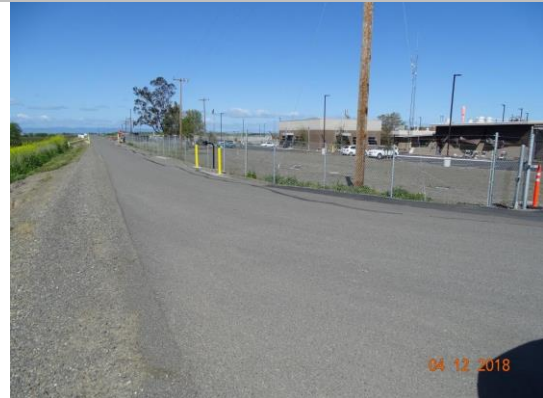
Photo 1 of 1 : FA\_2018\_ST0012\_295\_17\_20180904\_00004.jpg

View of fence on the landside shoulder. Spring 2018.

LM Start	0.02	Rating **	A/W	Issue No.	18
LM End	0.02	Issue Type +	Ma	Location *	
Category	Supplemental			GPS Latitude/Longitude	
				Start	End
Item	DWR UCIP LMA Responsibility			38.590766°	38.590766°
				-121.665560°	-121.665560°
DWR ID	17834

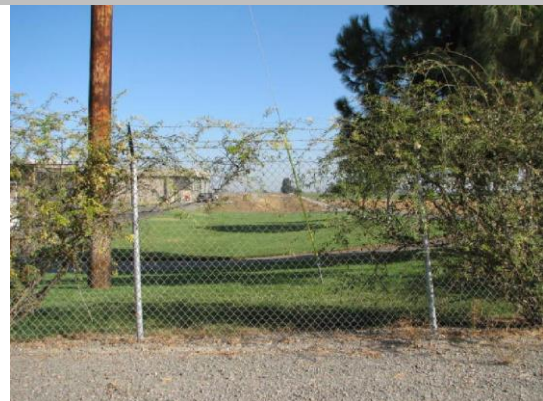
Photo 1 of 3 : UCIP\_FA\_2018\_44903\_22882.jpg

Comment Code					
Inspector Comment					
FS_ID:44903 DS_ID:17834 EP_NO: 10130 Repair Type: No Action Needed Crossing Status: Found UCIP Comments: 05/02/2017 CVFPB Letter sent April 12, 2012 regarding Permit #10130 - Internal Inspections of Pipes Crossing State Plan of Flood Control Levee. Permit No. 10130 previously referenced in UCIP record was removed--permit does not reference 36-inch pipe. (O. Magana - DWR UCIP) 04/12/2017 Mud/debris on WS removed by JK, RF. (C. Lund - DWR Sacramento Yard) 05/05/2015 Removed debris from the outlet. (C. Lund - DWR Sacramento Yard) 09/19/2012 Minor debris blocking flap gate. Debris/log needs to be removed from the outlet. (P. Amatya - DWR UCIP) FIELD_STRUCT_DESC: 36-inch corrugated metal drainage pipe through the levee, 18 feet below the crown. Flap gate is located on the waterside (WS) end. [Additional Reference(s): USACE Sacramento O&M Manual Unit 120, Willow Slough Channel Relocation and Levee Construction, February 1947, Drawing No. 50-4-2281 Sheet 4 (Station 271+54)] FS Date: 5/5/2015 8:02:11 AM

Landside view- beyond grass area see drainage inlet

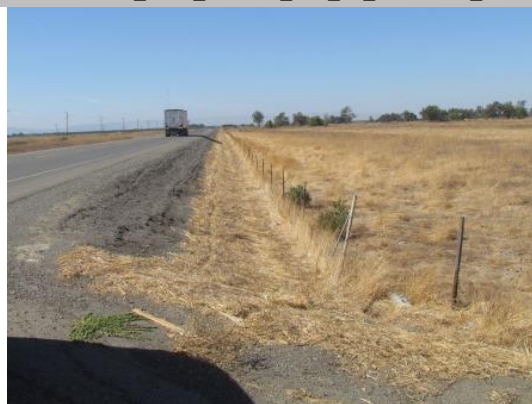
Photo 1 of 1 : FA\_2018\_ST0012\_295\_14\_20180904\_00003.jpg

LM Start	1.53	Rating **	M	Issue No.	14
LM End	2.20	Issue Type +	En	Location *	LS
Category	Earthen Levee			GPS Latitude/Longitude	
				Start	End
Item	Encroachments			38.590334 °	38.590466 °
				-121.693618 °	-121.705849 °
DWR ID	DWR_ST0012_01_f_2016_14				
Comment Code					
FE : Fence					
Inspector Comment					
Barbed wire fence.

View of fence encroaching 10-foot easement on landward side of the levee. Fall 2016.

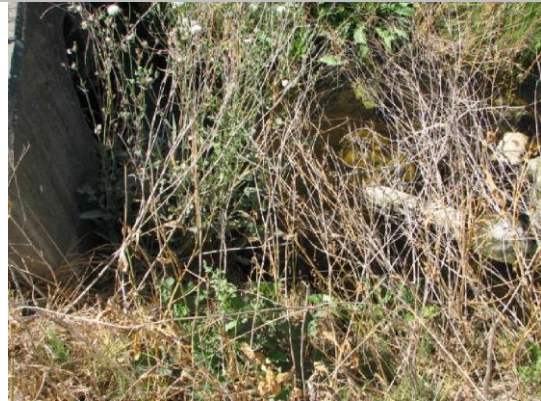
Photo 3 of 3 : UCIP\_FA\_2018\_44942\_22960.jpg

Landside view- vegetation around inlet.

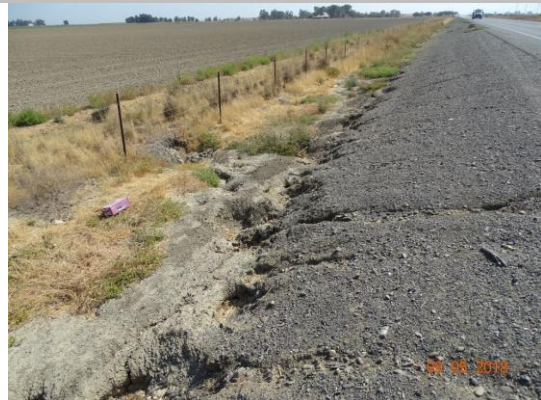
Photo 1 of 3 : FA\_2018\_ST0012\_295\_10\_20180905\_00005.jpg

Updated view of the erosion on the landside slope. Fall 2018.

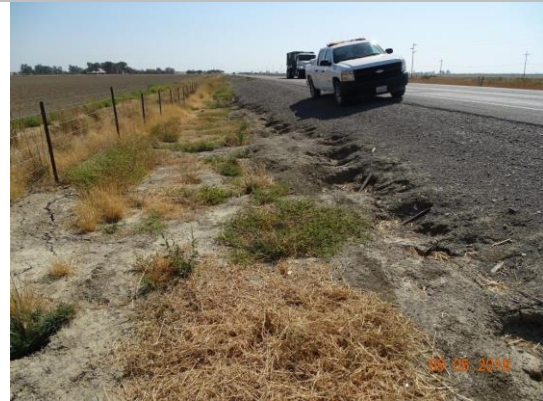
Photo 2 of 3 : FA\_2018\_ST0012\_295\_10\_20180905\_00006.jpg

Additional view of the erosion on the landside slope. Fall 2018.

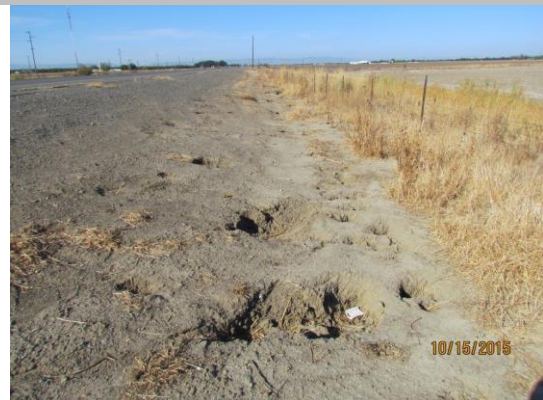
Photo 3 of 3 : FA\_2018\_ST0012\_295\_10\_20180904\_00002.jpg

View of the erosion on the landward side of the levee looking upstream. Fall 2015.

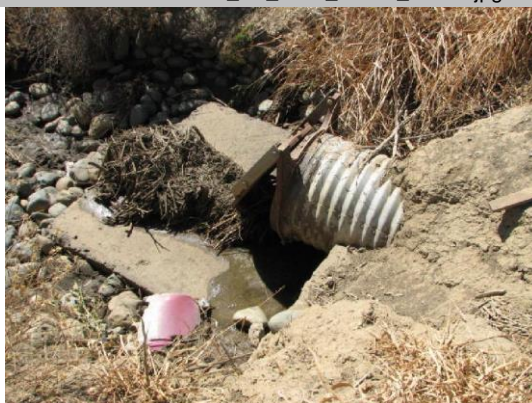
Photo 2 of 3 : UCIP\_FA\_2018\_44947\_22983.jpg

Waterside view- pipe, flap gate and debris.

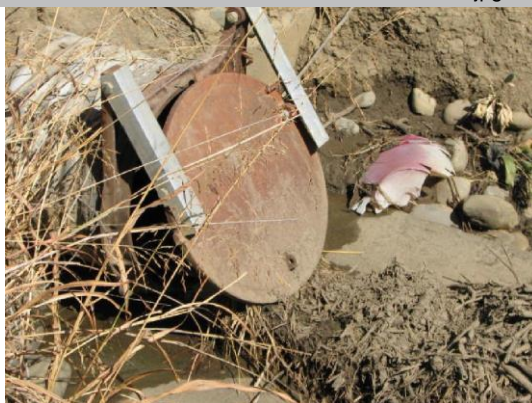
Photo 3 of 3 : UCIP\_FA\_2018\_44947\_22986.jpg

Waterside view- pipe, flap gate and debris. The pipe sits on concrete saddle.

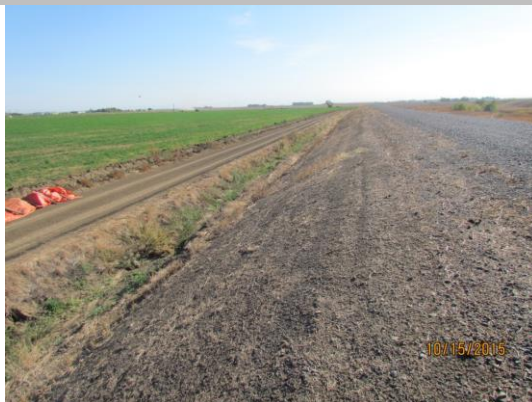
Photo 1 of 1 : FA\_2018\_ST0012\_295\_4\_20180904\_00001.jpg

View of the ditch on the landward side of the levee looking downstream. Fall 2015.

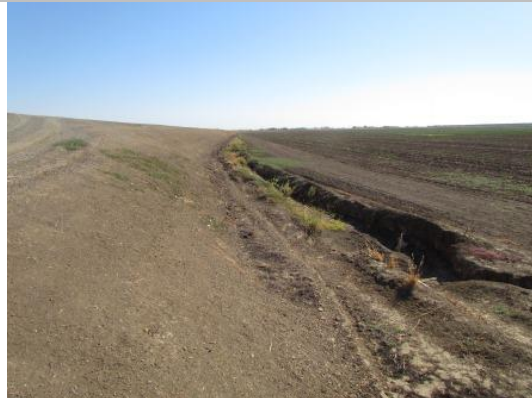
Photo 1 of 2 : FA\_2018\_ST0012\_296\_7\_20180904\_00004.jpg

An updated view of the ditch near LM 0.29. Fall 2016.

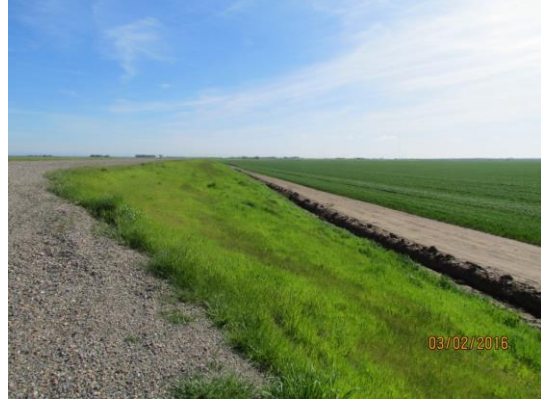
Photo 2 of 2 : FA\_2018\_ST0012\_296\_7\_20180904\_00005.jpg

View of the ditch on the landward side of the levee looking downstream. Spring 2016.

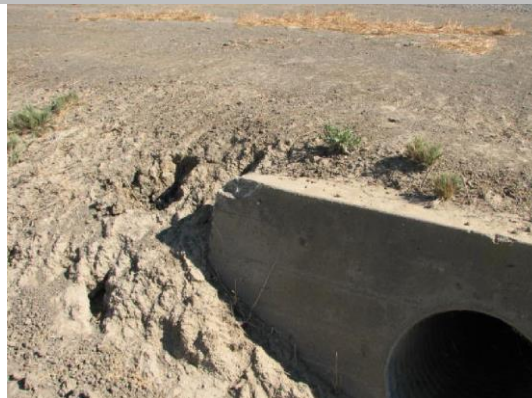
Photo 3 of 3 : UCIP\_FA\_2018\_13725\_22468.jpg

Landside view- concrete headwall corner chipped off

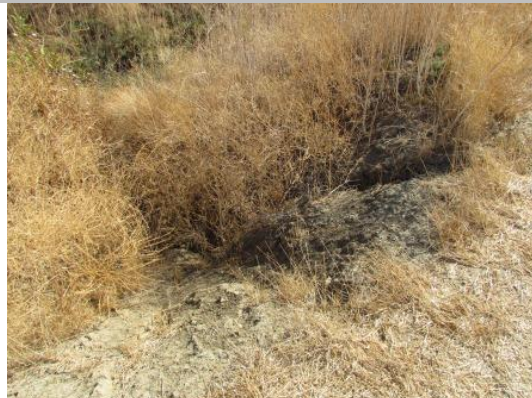
Photo 1 of 1 : FA\_2018\_ST0012\_296\_23\_20180904\_00026.jpg

View of an erosion site around UCIP pipe FSID 13725 on waterward side of the levee. Fall 2016.

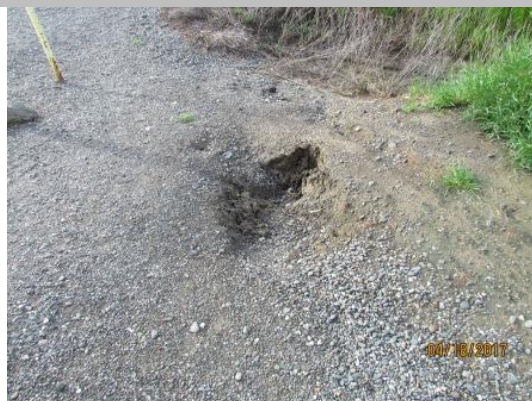
Photo 1 of 1 : FA\_2018\_ST0012\_296\_29\_20180904\_00028.jpg

View of tire damage on landside levee slope. Spring 2017.

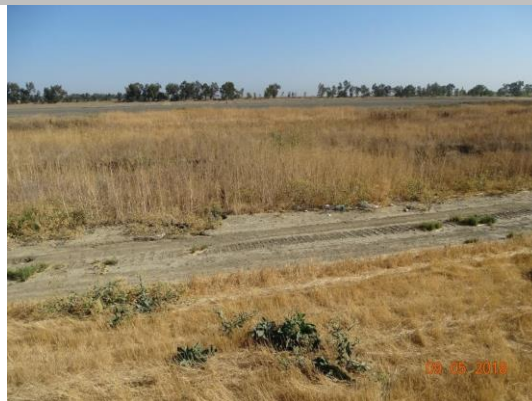
Photo 1 of 2 : FA\_2018\_ST0012\_296\_10\_20180905\_00032.jpg

Updated view of erosion on the waterside toe road. Fall 2018.

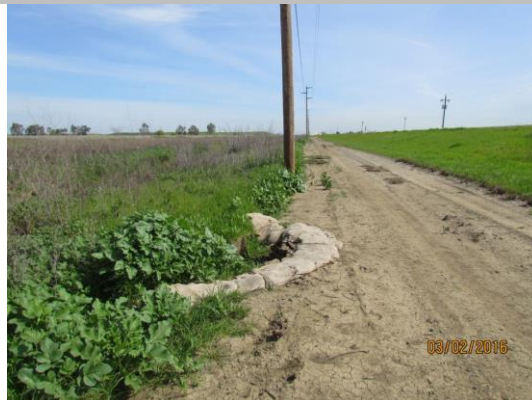
Photo 2 of 2 : FA\_2018\_ST0012\_296\_10\_20180904\_00011.jpg

View of the erosion on the toe road looking downstream. Spring 2016.

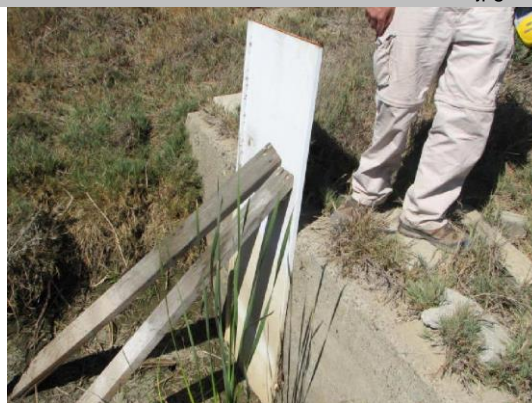
Photo 1 of 3 : UCIP\_FA\_2018\_45291\_22479.jpg

Landside view- concrete headwall and pipe (temporarily closed used wooden planks).

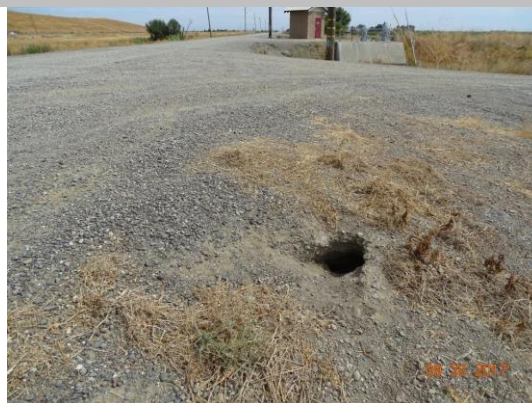
Photo 1 of 1 : FA\_2018\_ST0012\_296\_6\_20180904\_00003.jpg

View of burrow hole near access ramp on landside. Fall 2017.

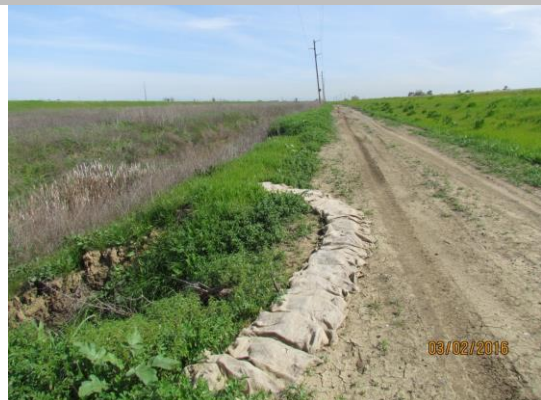
Photo 1 of 1 : FA\_2018\_ST0012\_296\_18\_20180904\_00022.jpg

View of the erosion on the waterward side looking downstream. Spring 2016.

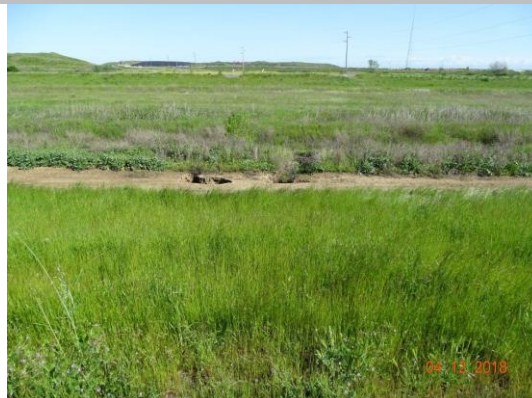
Photo 1 of 1 : FA\_2018\_ST0012\_296\_24\_20180904\_00027.jpg

View of erosion on the waterside toe road. Spring 2018.

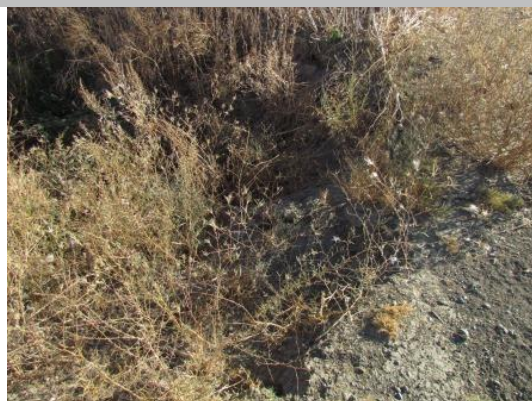
Photo 1 of 3 : FA\_2018\_ST0012\_296\_11\_20180904\_00012.jpg

An updated view of the erosion site near the WS levee slope. Fall 2016.

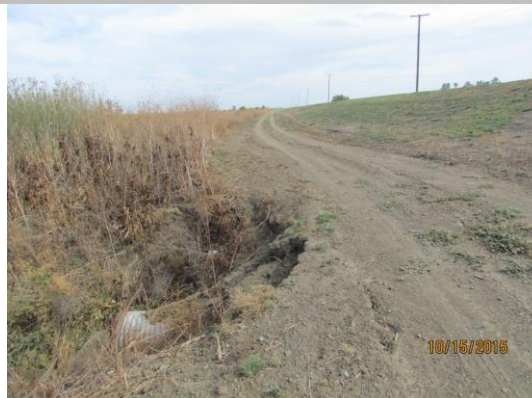
Photo 3 of 3 : FA\_2018\_ST0012\_296\_11\_20180904\_00014.jpg

View of the erosion at the edge of the channel on the waterward side of the levee looking downstream. Fall 2015.

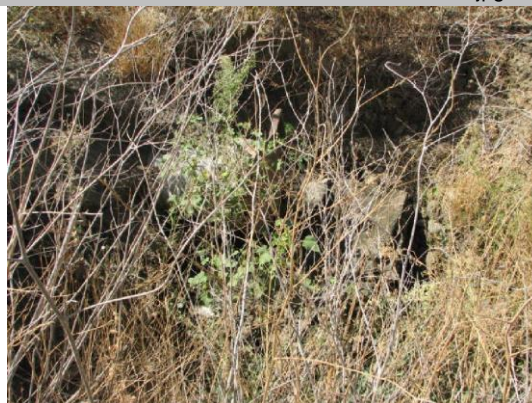
Photo 1 of 3 : UCIP\_FA\_2018\_45298\_22805.jpg

Waterside overview- pipe and flap gate with dense vegetation.

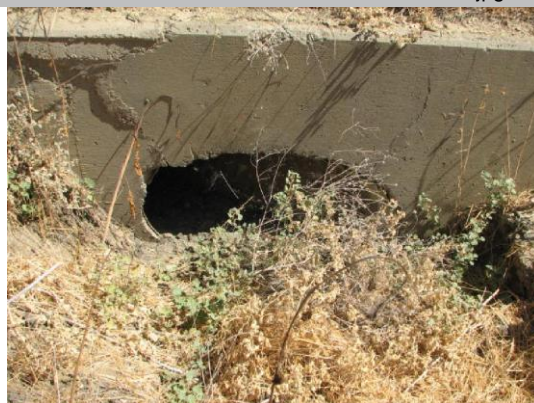
Photo 3 of 3 : UCIP\_FA\_2018\_45285\_22810.jpg

Landside view- soil and debris on mouth of the inlet pipe.

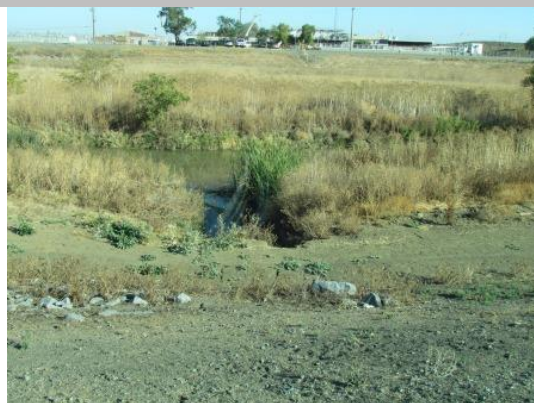
Photo 1 of 3 : FA\_2018\_ST0012\_296\_15\_20180904\_00018.jpg

An updated view of the erosion site near the levee slope. Fall 2016.

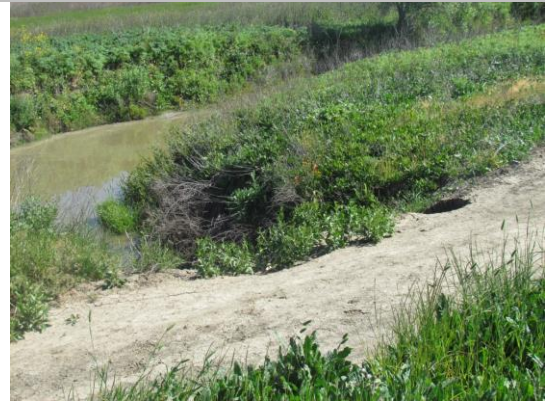
Photo 2 of 3 : FA\_2018\_ST0012\_296\_15\_20180904\_00019.jpg

View of the erosion on the edge of the channel on the waterward side of the levee. Spring 2015.

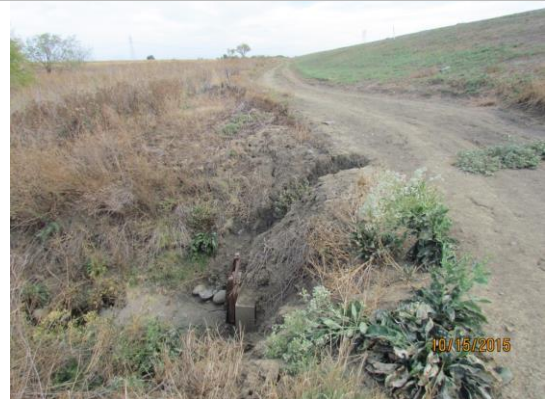
Photo 3 of 3 : FA\_2018\_ST0012\_296\_15\_20180904\_00020.jpg

View of the erosion at the edge of the channel on the waterward side of the levee looking downstream. Fall 2015.

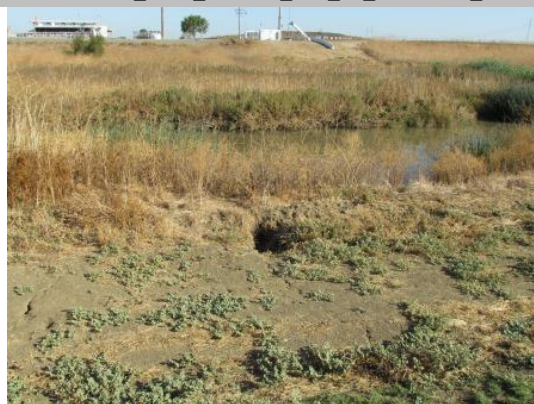
Photo 1 of 1 : FA\_2018\_ST0012\_296\_17\_20180904\_00021.jpg

View of a site that may become a larger erosion site in the future. Waterward side of the levee looking downstream. Fall 2016.
